Soft Option

Contemporary technology turns back the clock at the Marion County Courthouse in West Virginia.

BY LYNNE LAVELLE

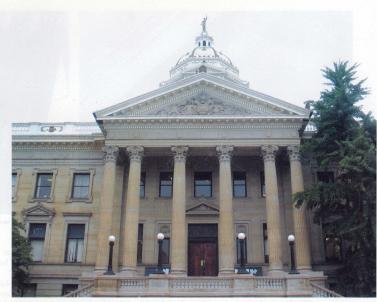
The repair, cleaning and painting of the cast-iron elements was the first phase of the ongoing structural and cosmetic restoration of Marion County Courthouse in Fairmont, WV. All photos: courtesy of Sponge-Jet, Inc.

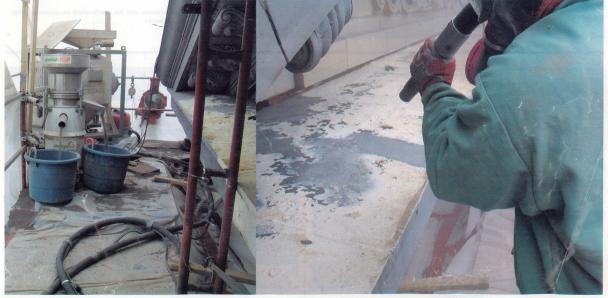
The Sponge-Jet blasting system was located on the same level as the work being done, allowing blasting and recycling to be carried out within feet of the blaster.

Sponge-jet cleaning, a dry alternative to conventional abrasives, first came to Kemnitzer's attention in 2003. Developed in the late 1980s, it combines a recyclable sponge-like polymer with conventional abrasive grit, in a range of particle sizes for aggressive or clean-only applications. Although most conventional abrasives can be engineered into sponge media, the most commonly used types are aluminum oxide, metal grit, calcium carbonate, 40–60 mesh type III melamine, 30/40 and mesh type II plastic urea. The sponge particles are fired at the surface, where they flatten on impact, exposing banded abrasives and dislodging contaminants. After dropping from the surface, the sponges regain their original shape. A vacuum system recovers the sponges, transports them to a machine that removes contaminants, and then reloads them for almost continuous blasting, all within feet of the treated surface.

The Sponge-Jet system had been successfully applied in the masonry restorations of the Wisconsin and Idaho state capitols, returning the white-granite facades to their original condition. And with no run-off, low dust emissions and, in some applications, only 3% of the waste generated by conventional abrasives, it fit the criteria for the cast iron at the Marion County Courthouse. 'I read a lot of the literature and it seemed to be ideal,' says Kennitzer. 'It had the advantage of keeping all of that lead contained. And they had worked out a process for cleaning the

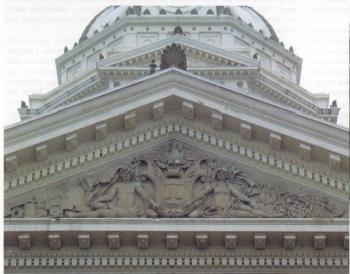
Above: Heavy-loading scaffolding was erected around the front entrance of the Marion County Courthouse while its cast-iron elements were repaired, cleaned and renainted.
